Asbestos In Soil:

An Analytical & Occupational Hygienist View

Pickford & Rhyder Consulting Pty Ltd

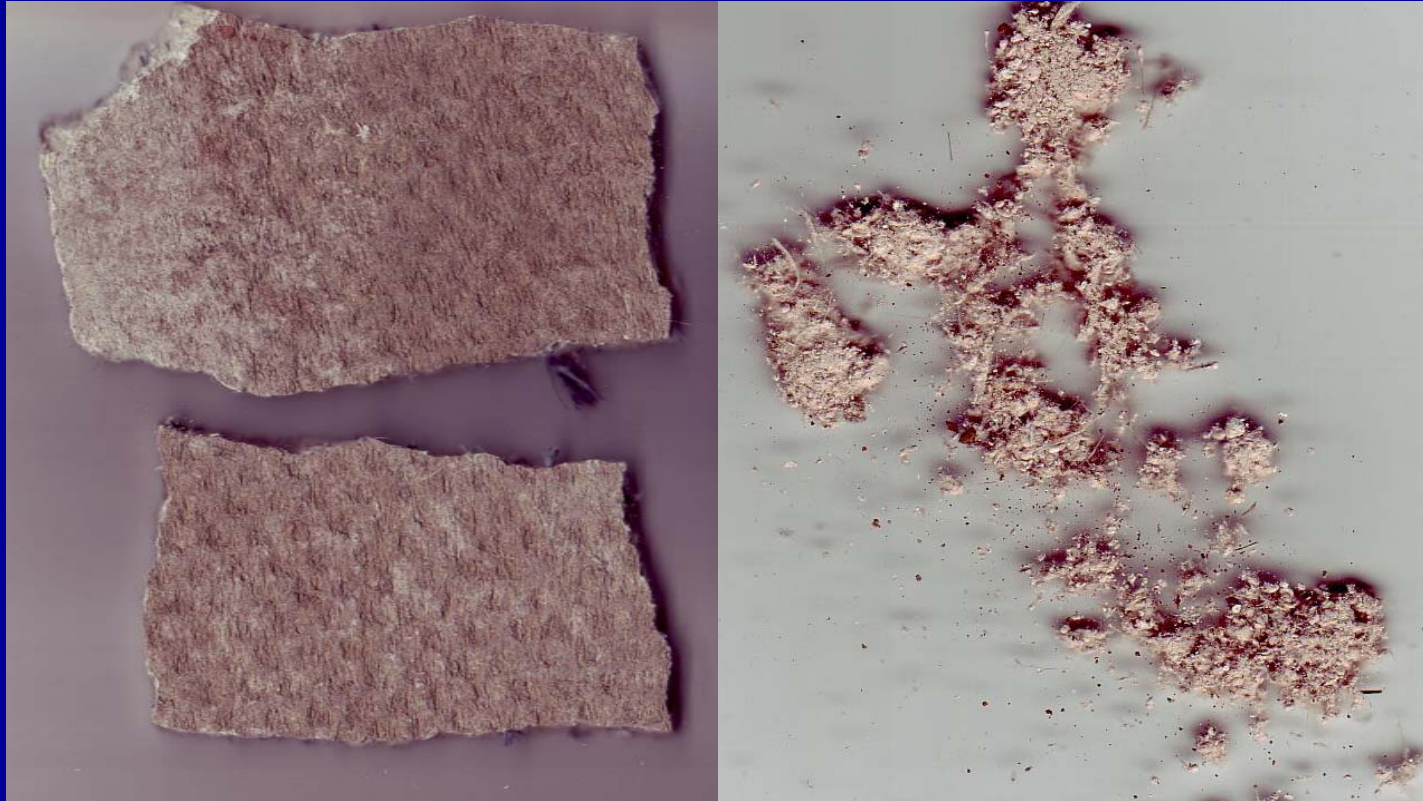
Bonded – fibres locked into matrix, e.g. asbestos cement

Friable – crushed in fingers, e.g. pipe lagging

If friable, likelihood of 'free' or 'respirable' fibres is possible (respirable fibres are $>5 \mu\text{m}$ long, $<3 \mu\text{m}$ wide).

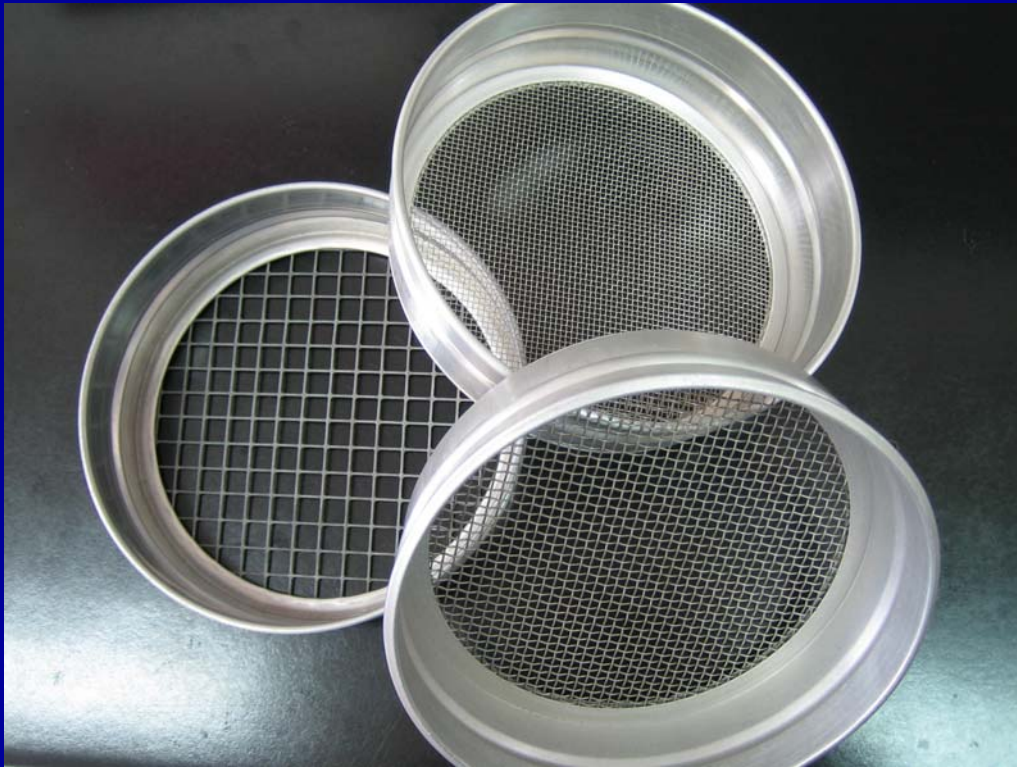
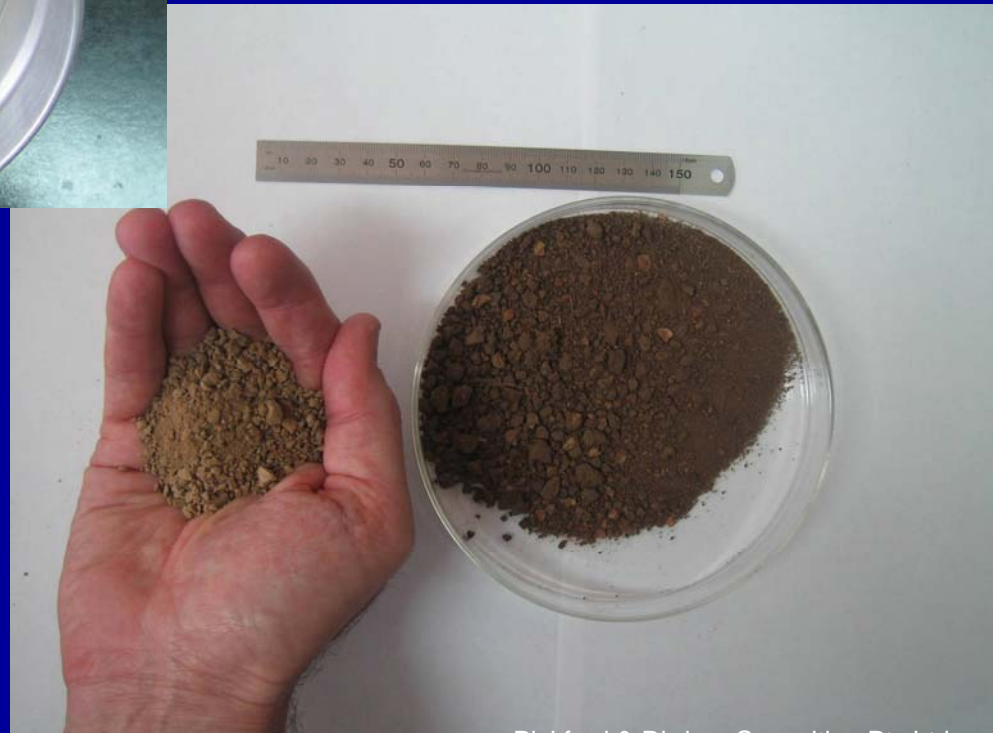
Asbestos Analysis - Identification

- Asbestos identification analysis uses polarized light microscopy (i.e. visual method)
- Fibres meeting certain criteria can be unequivocally identified as chrysotile (white), amosite (brown) or crocidolite (blue) asbestos
- Organic and synthetic mineral fibres can also be reported
- Trace analysis **must** be conducted on all soil samples
- Ensure results of trace analysis are included on report
